**ENGINE REBUILDERS ASSOCIATION**  
**Oil Pump Replacement Caution on**  
**2004-2008 Suzuki 2.0L Engines**

Models affected: Forenza Sedan/Wagon, Reno (RQ420)

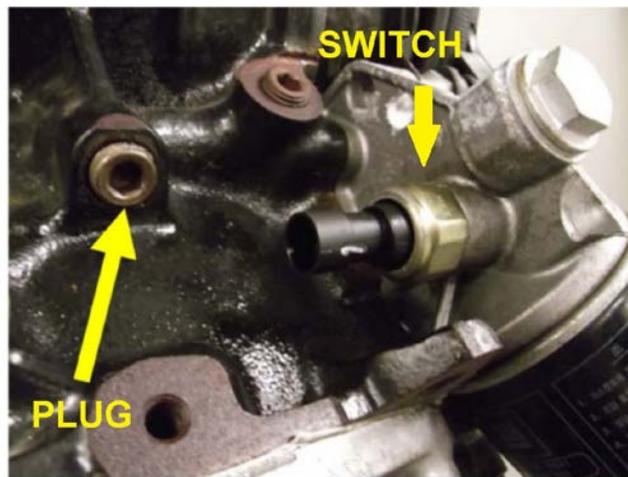
The original design of the oiling system on this engine has the oil pressure switch located in the external portion of the oil pump assembly as shown in Figure 1. When a new original equipment pump is being replaced it is important to note, New Suzuki replacement oil pumps are supplied with a threaded plug installed into the previously used oil pressure switch port. This plug is very difficult to remove without damaging the new oil pump by causing distortion and thread damage. The plug should be left undisturbed as viewed in Figure 2.

Figure 1. Left Arrow Gallery Plug, Right Original Switch Location

New oil pump replacement also requires re-location of the oil pressure switch to the block header, a short distance away as show in Figure 1.

To relocate the existing switch or a new switch Part #37820-86Z02, obtain a new gasket and install into the block, torquing it to 30 FT/LBS. Connect the existing wire harness to the oil pressure switch. No modifications are required to the harness length or connector for the relocation of the switch.

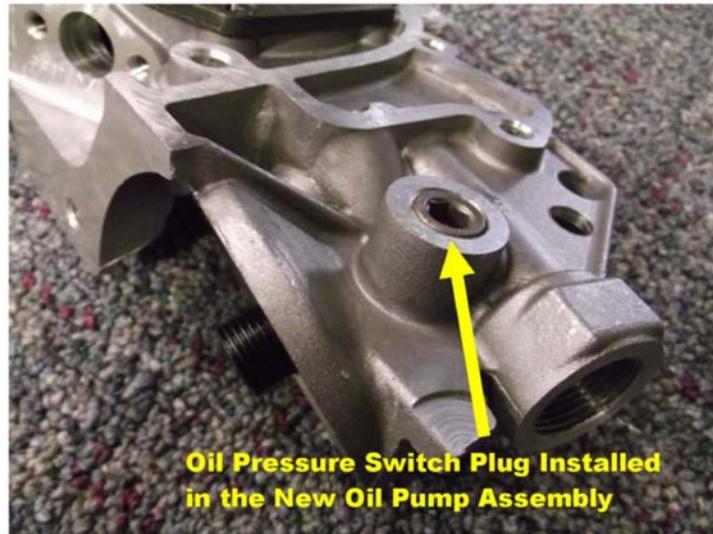
Figure 2. New Oil Pump Sealed Plug – Do Not Remove
